# Manhole Inspection Summary

Manhole # S15CC2009MH

**Location** Address: **5702 RANNY RD** Cross Street: **SULGRAVE AVE**

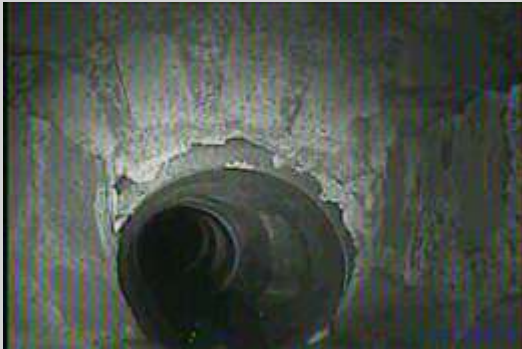
### 8 in. Circular Gravity Sewer Pipe Out @ 12 O'Clock

Pipe Material: **Clay** ☐ Pipe Lined

Invert Depth: **10.13** (ft.) Flow Characteristics: **Slow**

Infiltration: **None** Pipe Seal Cond: **Unknown**

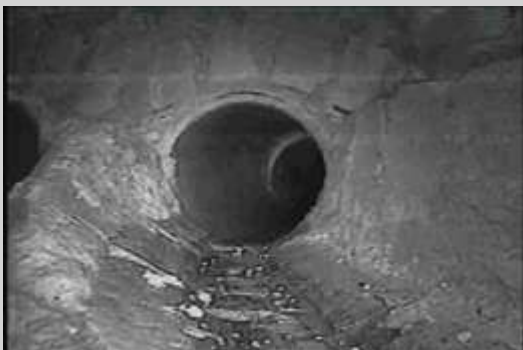
### 6 in. Circular Gravity Sewer

Pipe Material: **Clay** ☐ Pipe Lined

Infiltration: **None** Pipe Seal Cond: **Unknown**
